COMPUTATION BOOK

TPC II

CONU SYSTEMS

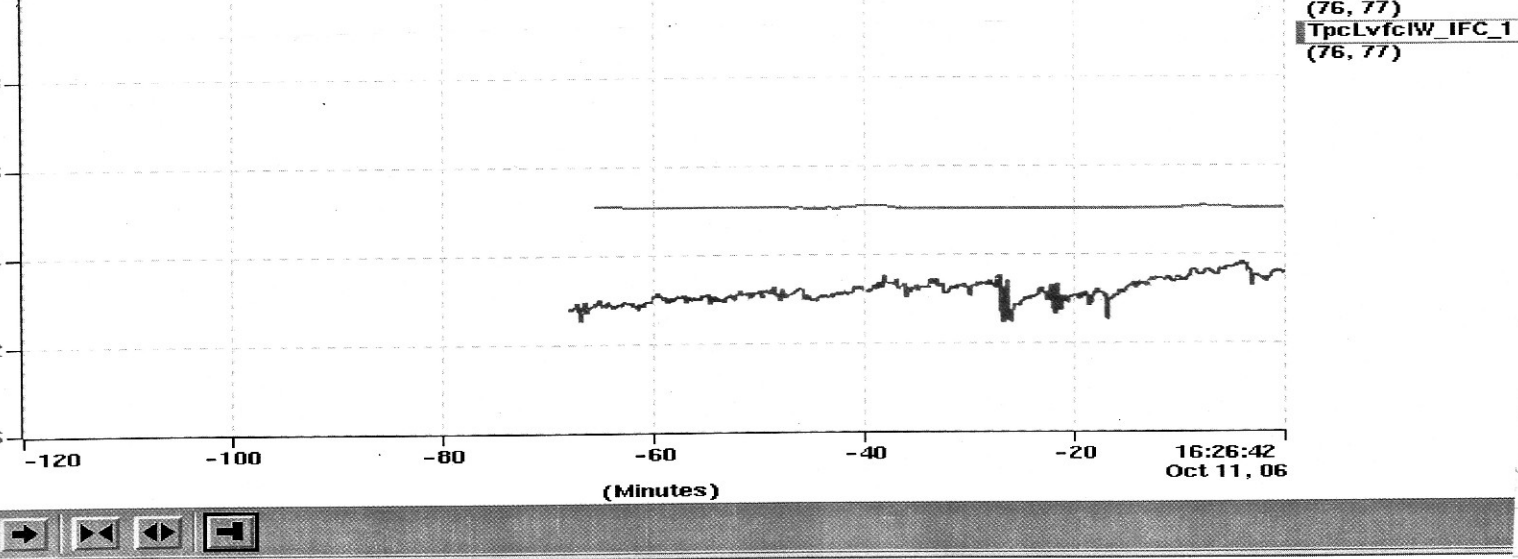
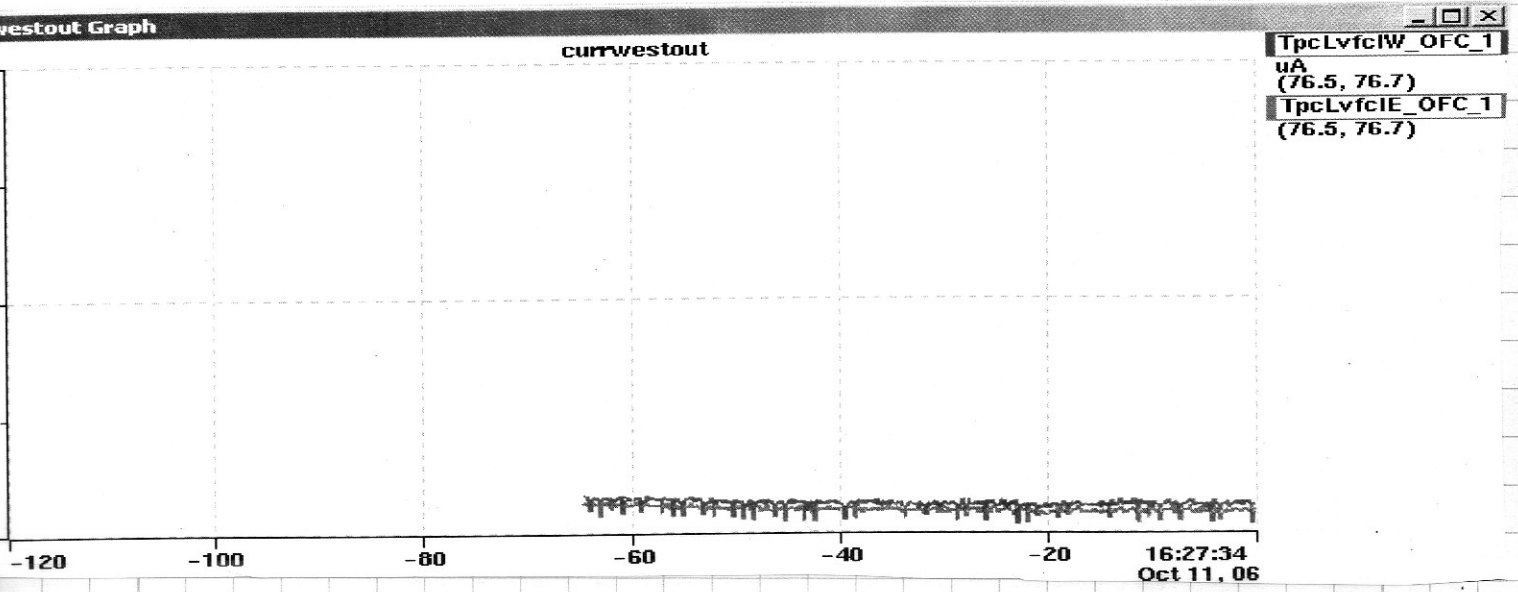
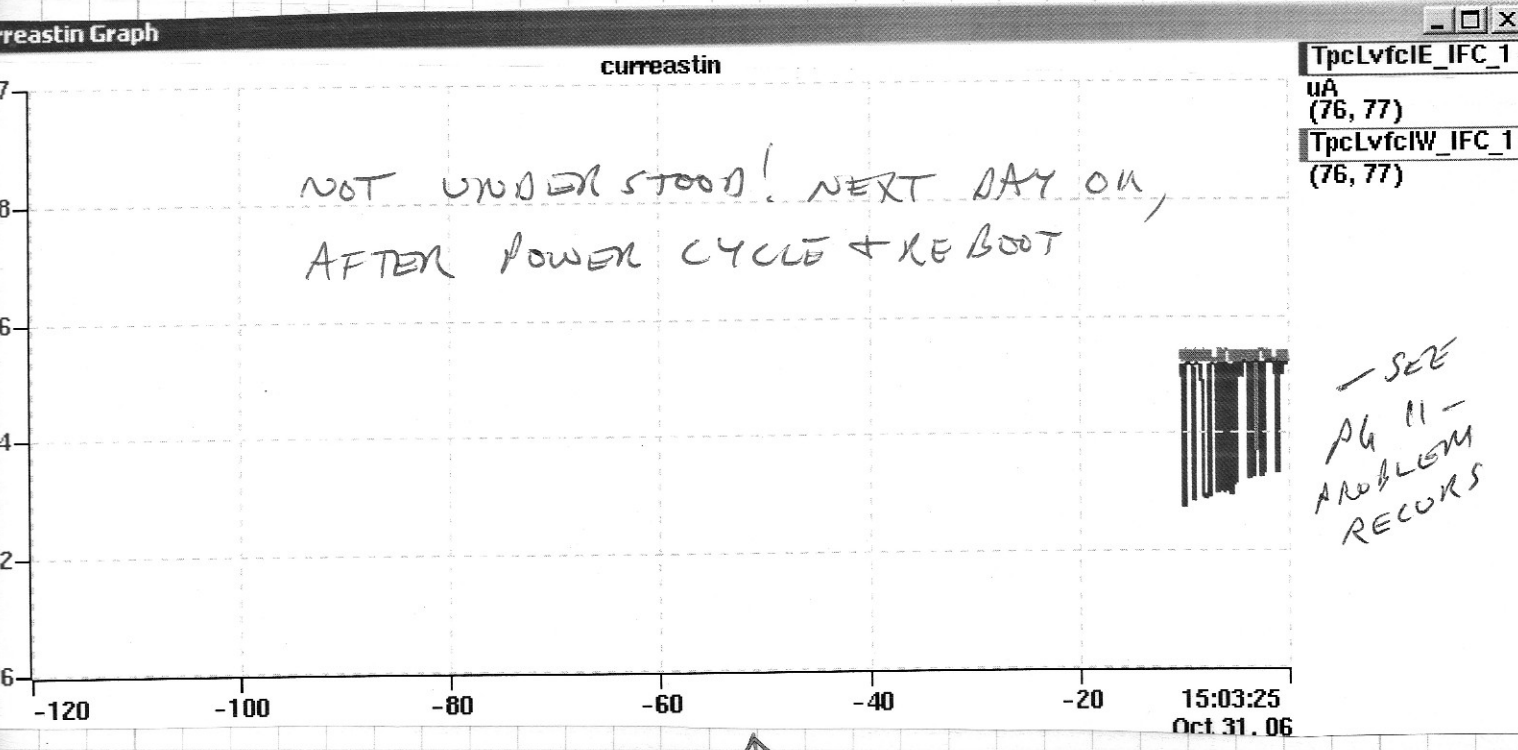
76.240 LOOKS BI-STABLE!?

(76, 77)
TpcLvfcIW_IFC_1
(76, 77)

TpcLvfcIW_OFc_1
uA
(76.5, 76.7)
TpcLvfcIE_OFc_1
(76.5, 76.7)

TpcLvfcIE_IFC_1
uA
(76, 77)
TpcLvfcIW_IFC_1
(76, 77)

NOT UNDERSTOOD! NEXT DAY OK,
AFTER POWER CYCLE + REBOOT

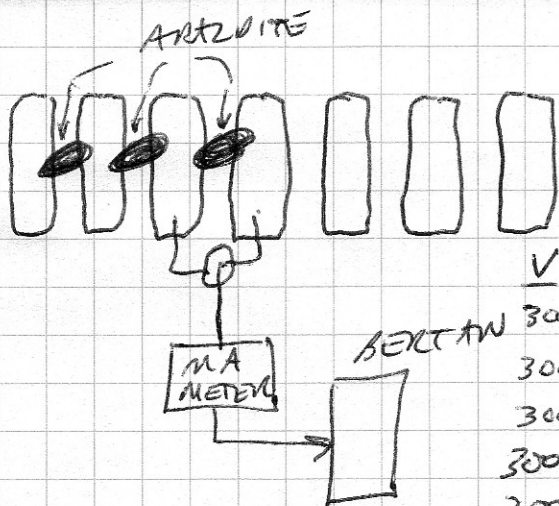
SET UP TO MEASURE CURRENT ACROSS GAP

V	TIME	CURRENT
	300	1400 7/2/07	20 nA
	300	1600	50 nA
	300	0900 7/3	104 nA
	300	1400	95 nA
	300	1030 7/5	316 nA
	300	1430 7/5	320 nA
	300	0830 7/6	304 nA
	300	1100 7/6	320 nA
HUMIDITY HI	{ 300	1030 7/10	440 nA
	{ 700	1030 7/11	480 nA
HUMIDITY DOWN	300	7300 7/12	322 nA
		1000 7/13	329 nA
		1500 7/16	434 nA

7/16/07 MOVE TO A GAP WITH NO EPOXY BRIDGE - STILL GET \sim 430 nA \Rightarrow SURFACE EFFECT?

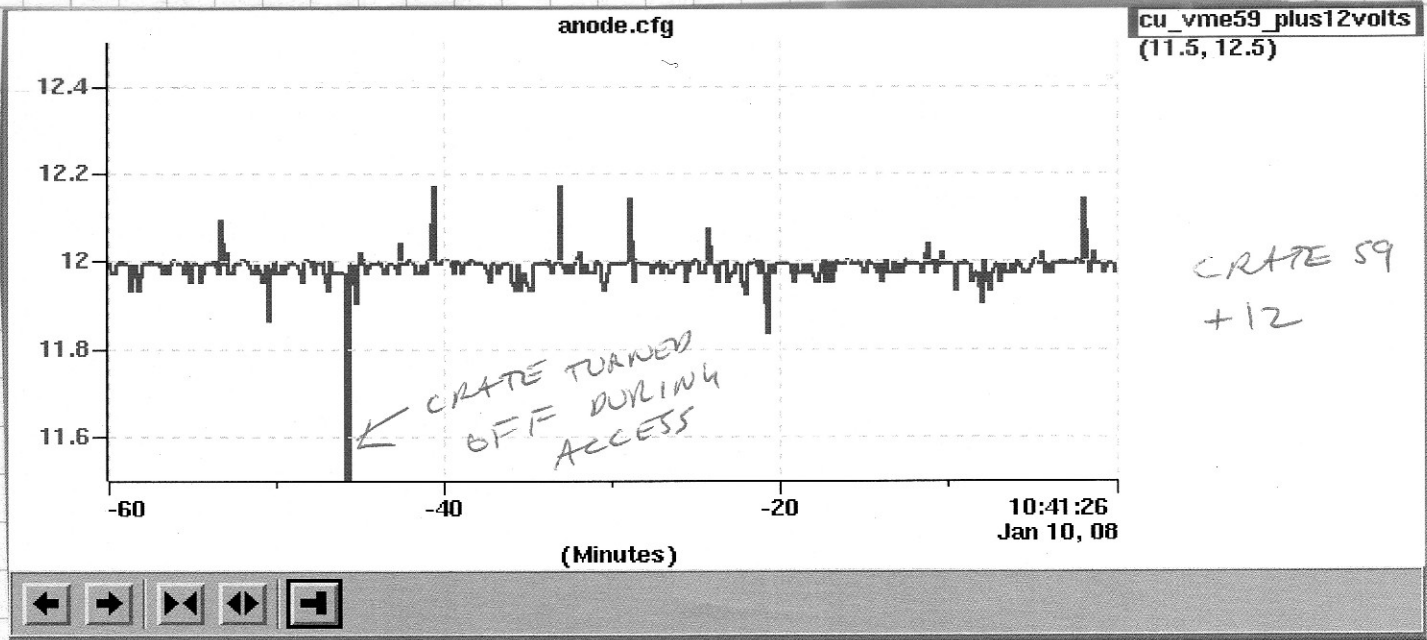
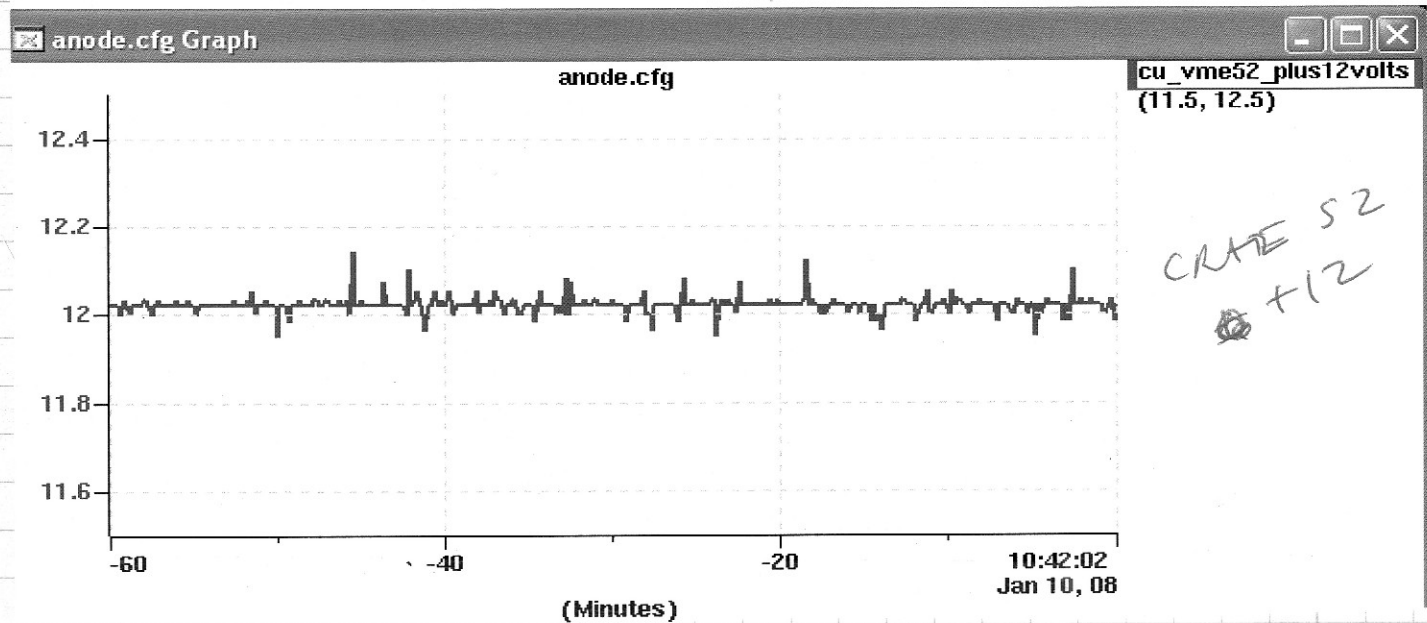
- 1/10/08 0900 ONE NOTE IN LOG OVERNIGHT ABOUT OUTER ARCWELT - CRATE? THEN CRATE TURNS OFF AT ~0740. TURNED BACK ON BY OP. GET ACCESS & SET +12V LOWER TRIP FROM 11.7 TO 11.5V (SET BY CONTROLS ON FAN TRAY - SLOW CONTROLS SEEMS NOT TO WORK FOR SETTING LIMITS. ALSO NOTICE THAT +12V IN CRATE 59 VARIES A LOT. SEE STRIP CHARTS
