Two shorts on OFC West

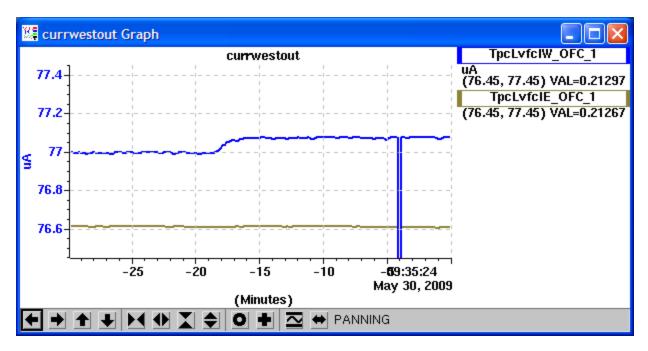
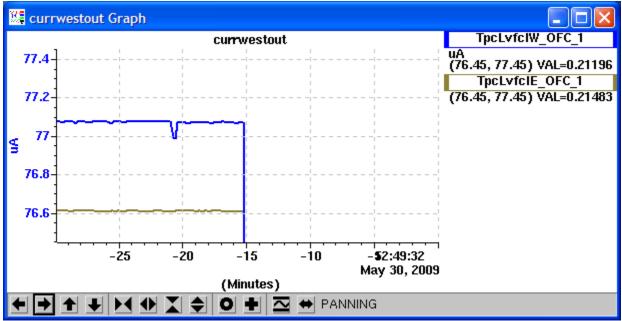
The curious feature about the intermittent short is that it takes about 1 minute to turn on. This is shown in the expanded plot shown below. The third figure shows the intermittent short turning off briefly, and then back on again.
